# The Pentagon Lightwell Walls

Repair, Rehabilitation and Protection for the Next 50 Years

By Rick Edelson

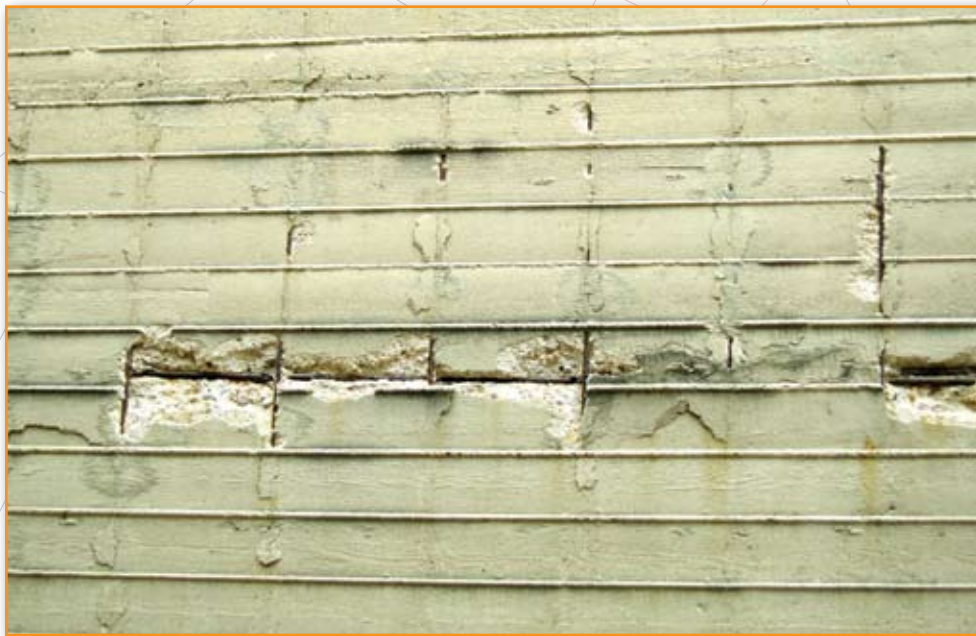
Figure 1: Typical lightwell wall damage showing spalling and exposed rusting reinforcing bars.

The problem is corrosion, i.e., rusting, of the reinforcing bars in the lightwell walls and related spalling damage caused by the expansive forces created by the rusting bars. As steel rusts, it expands 4 to 10 times its original size creating extreme tensile forces in the surrounding concrete. From these tensile forces, the concrete cracks the spalls. The Pentagon program is about the repair and rehabilitation of the more than 250,000 square feet of spalling, typically represented in *Figure 1*, plus an innovative protection system designed to resist the damage for the next 50+ years.

The Structural Engineer of Record for the concrete repair program designed the concrete repair work closely following the International Concrete Repair Institute guidelines for concrete repair. All damaged and spalling concrete, some 3 to 4 inches deep, is removed with 15-pound jack hammers, fully exposing rusting reinforcing bars. Where corrosion has extended around a bar, the bar is undercut; this allows the full surface of the bar to be sandblasted clean, removing all rust. Working closely with U.S. Concrete Products, Timonium, MD, the manufacturer of the repair concrete, a color matching, low shrinkage, pumpable repair concrete was developed to comply with the Specifications which require a color and texture match when viewed from a distance of 30 feet (the view from any window across a lightwell). This is easier said than done. Although some of the repairs are as much as 4 inches deep, some repairs are less than 1 inch deep, and some are too small to economically build formwork. For the minor amount of hand patching that is being performed on small repairs, a trowelable mix was developed. For the remaining repairs, U.S. Concrete developed a polymer modified, plasticized, bagged material that is mixed onsite. This material easily flows into the formed repairs with extremely little shrinkage cracking. The mix allows repairs up to 4 inches deep without large aggregate extension, and almost no cracking. Simple external vibration is all that is needed for good consolidation. And, it obtains at least 2000 psi in under 3 days, to allow for early stripping.

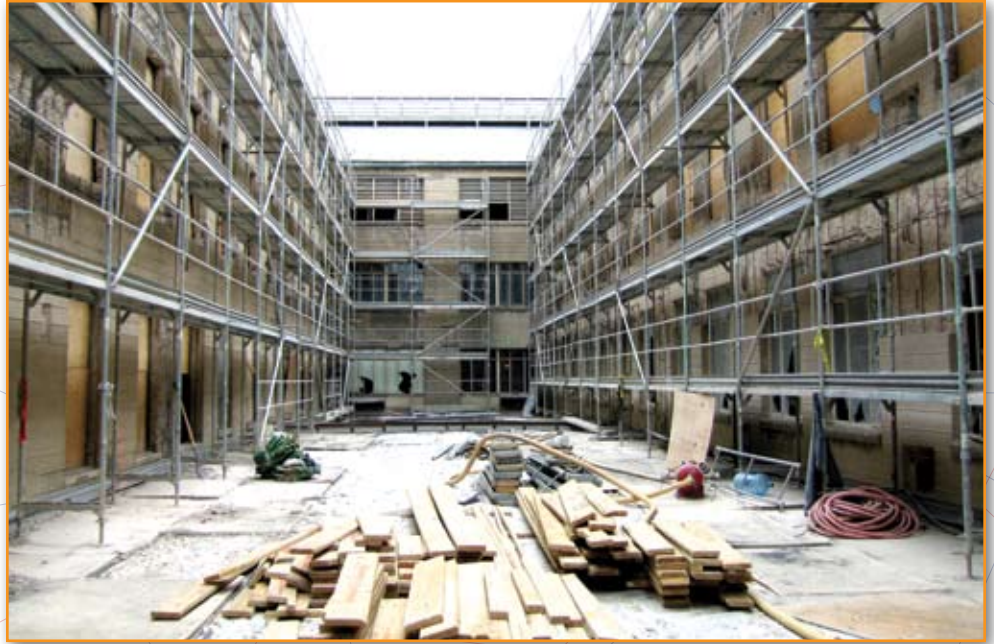
Figure 2: Scaffolding constructed to allow direct access to walls.

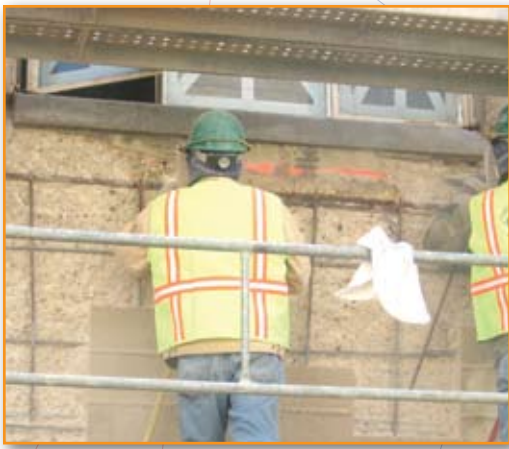
Figure 3: Jackhammer demolition in progress exposing corrosion damaged reinforcing bars.

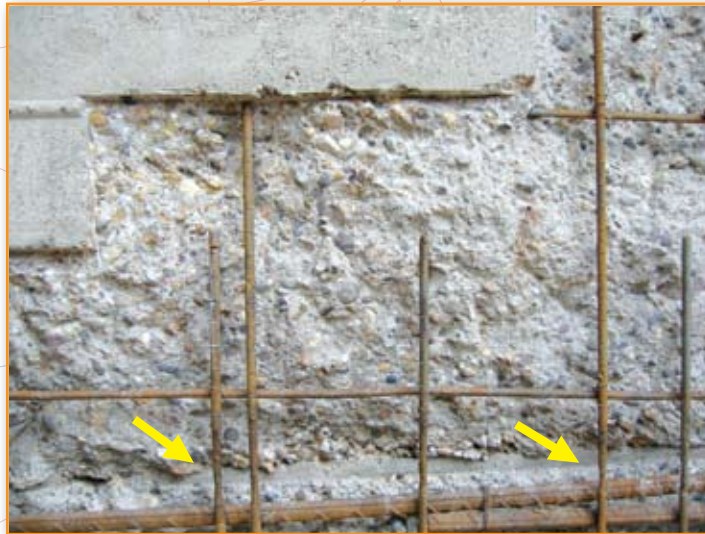
Figure 4: Close view of corrosion damaged reinforcing bars taken after completion of jackhammer demolition. Note the severe loss of cross section at the bottom of the vertical bars in the photo.

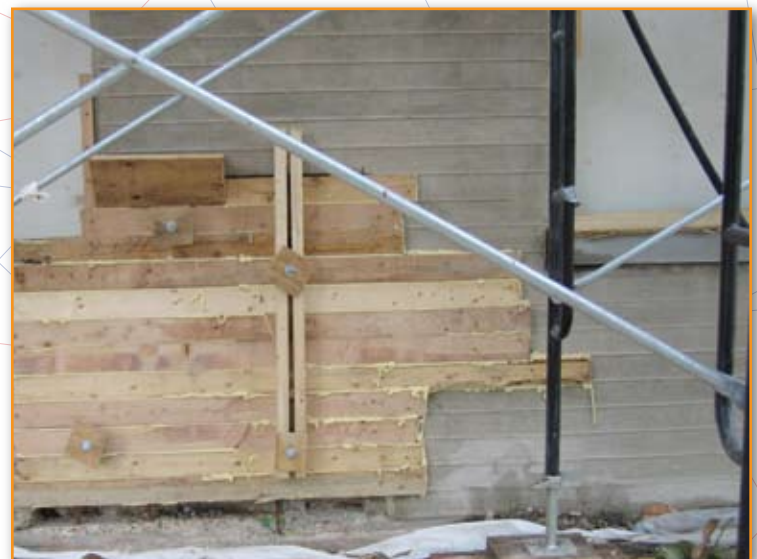
Figure 5: Formwork in place constructed to match original formboard finish on the existing walls.

Concrete Protection and Restoration, Inc., the concrete repair subcontractor, developed a formwork system (Figure 5) which allows easy placement of the repair concrete, as well as a match to the original form board finish. After

trial and error, they quickly learned that the best method of forming was to use the same 2x12 board construction, just like the original contractor did in 1944, thus creating a perfect match to the original finish.

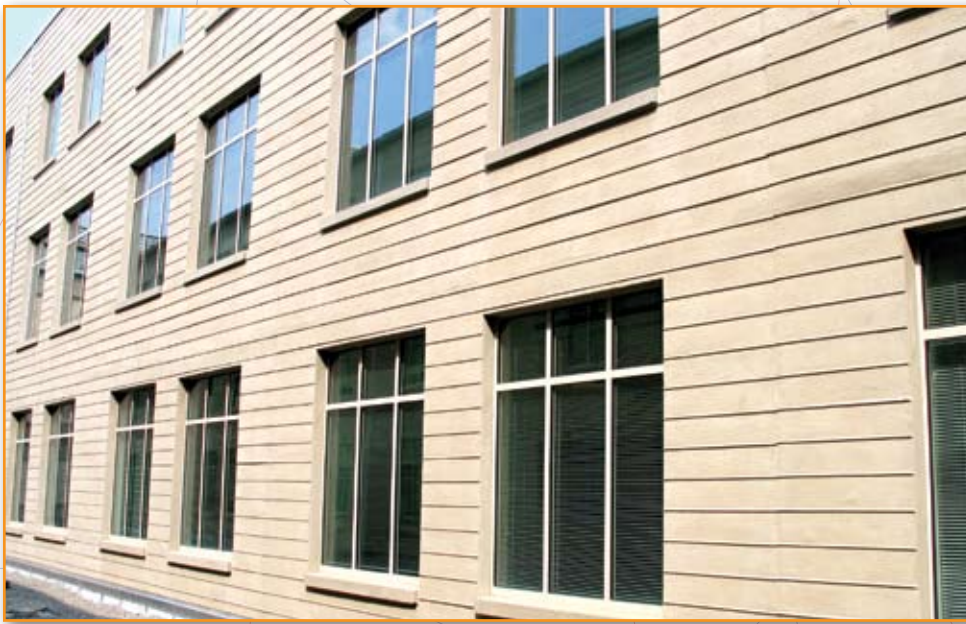
Figure 7: Complete wall ready for presentation.

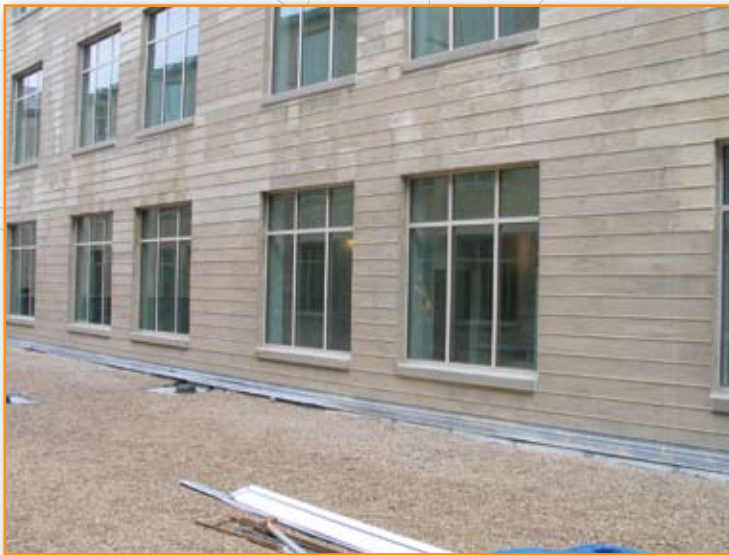
Figure 6: Portion of wall completed prior to application of silane and potassium silicate coating.

But, corrosion rate reduction is only half the battle. Without water, corrosion can be halted. How to stop water from absorbing into the walls for 50 years? Further protection is provided by a system reducing the absorption of water into the walls. A 100% solids silane is applied to the wall surface, after the application of the corrosion inhibitor, to reduce absorption and to repel water. Silane is a water repellent only and breaks down when exposed to ultraviolet light. To further protect the walls, a much more durable surface is needed, one which will last 50+ years and will prevent the breakdown of the silane. To accomplish this, potas-

sium silicate was selected to enhance the surface and to protect both the water repellent and the corrosion inhibitor. Potassium silicate, originally developed and manufactured in Germany by Keim over 100 years ago, is reported in their literature to remain in service today 100 years later. The potassium silicate itself also resists water absorption by creating a tough, water resistant mineral surface on the concrete. With both the potassium silicate and the silane, water now sheds off the surface of the concrete. In addition, a uniform color is achieved with the addition of pigments to the potassium silicate, further improving the repair to meet the required Specification of a color match as seen across the lightwells.

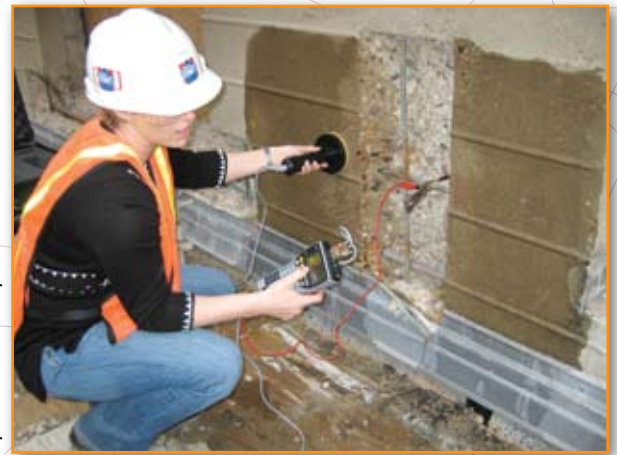
Figure 8: Corrosion rate monitoring of corrosion activity in unrepaired portion of wall adjacent to exposed corrosion damage.
