**「即固E-120」  
快速修補戰備水泥砂漿  
公車道鋼性路面破損修補**

# 「即固E-120」 快速修補戰備水泥砂漿

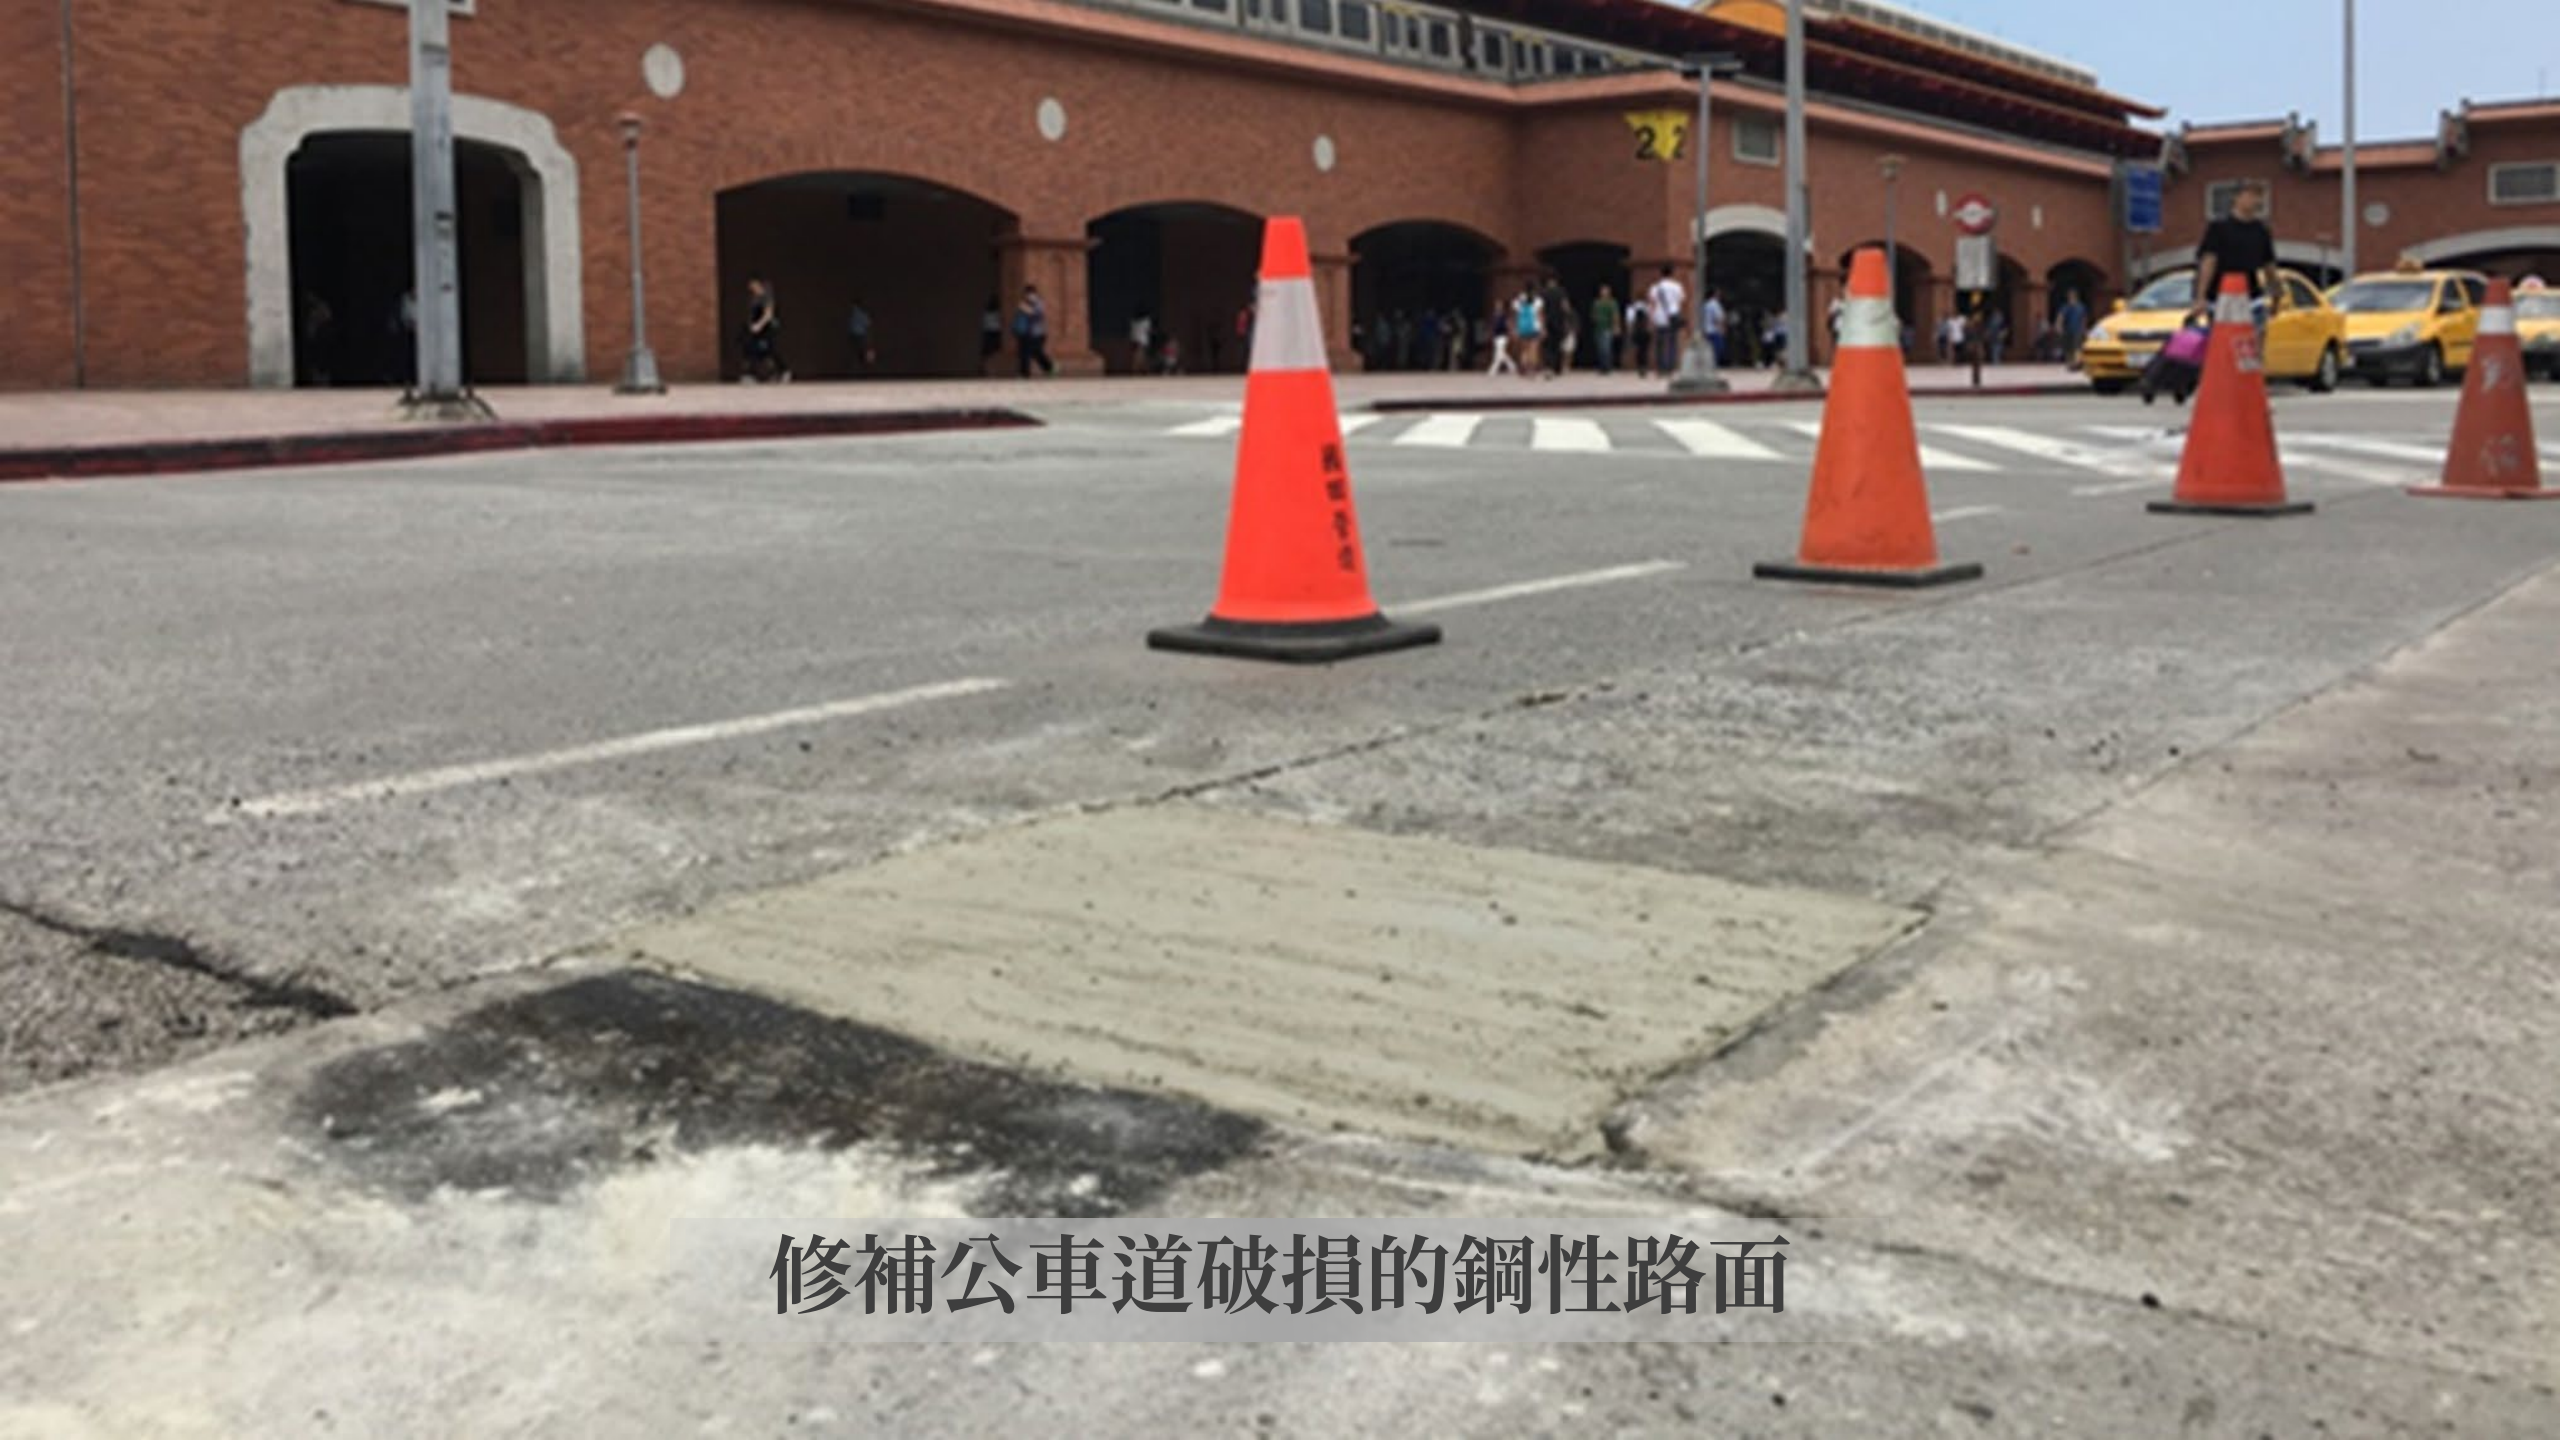
修補公車道破損的鋼性路面

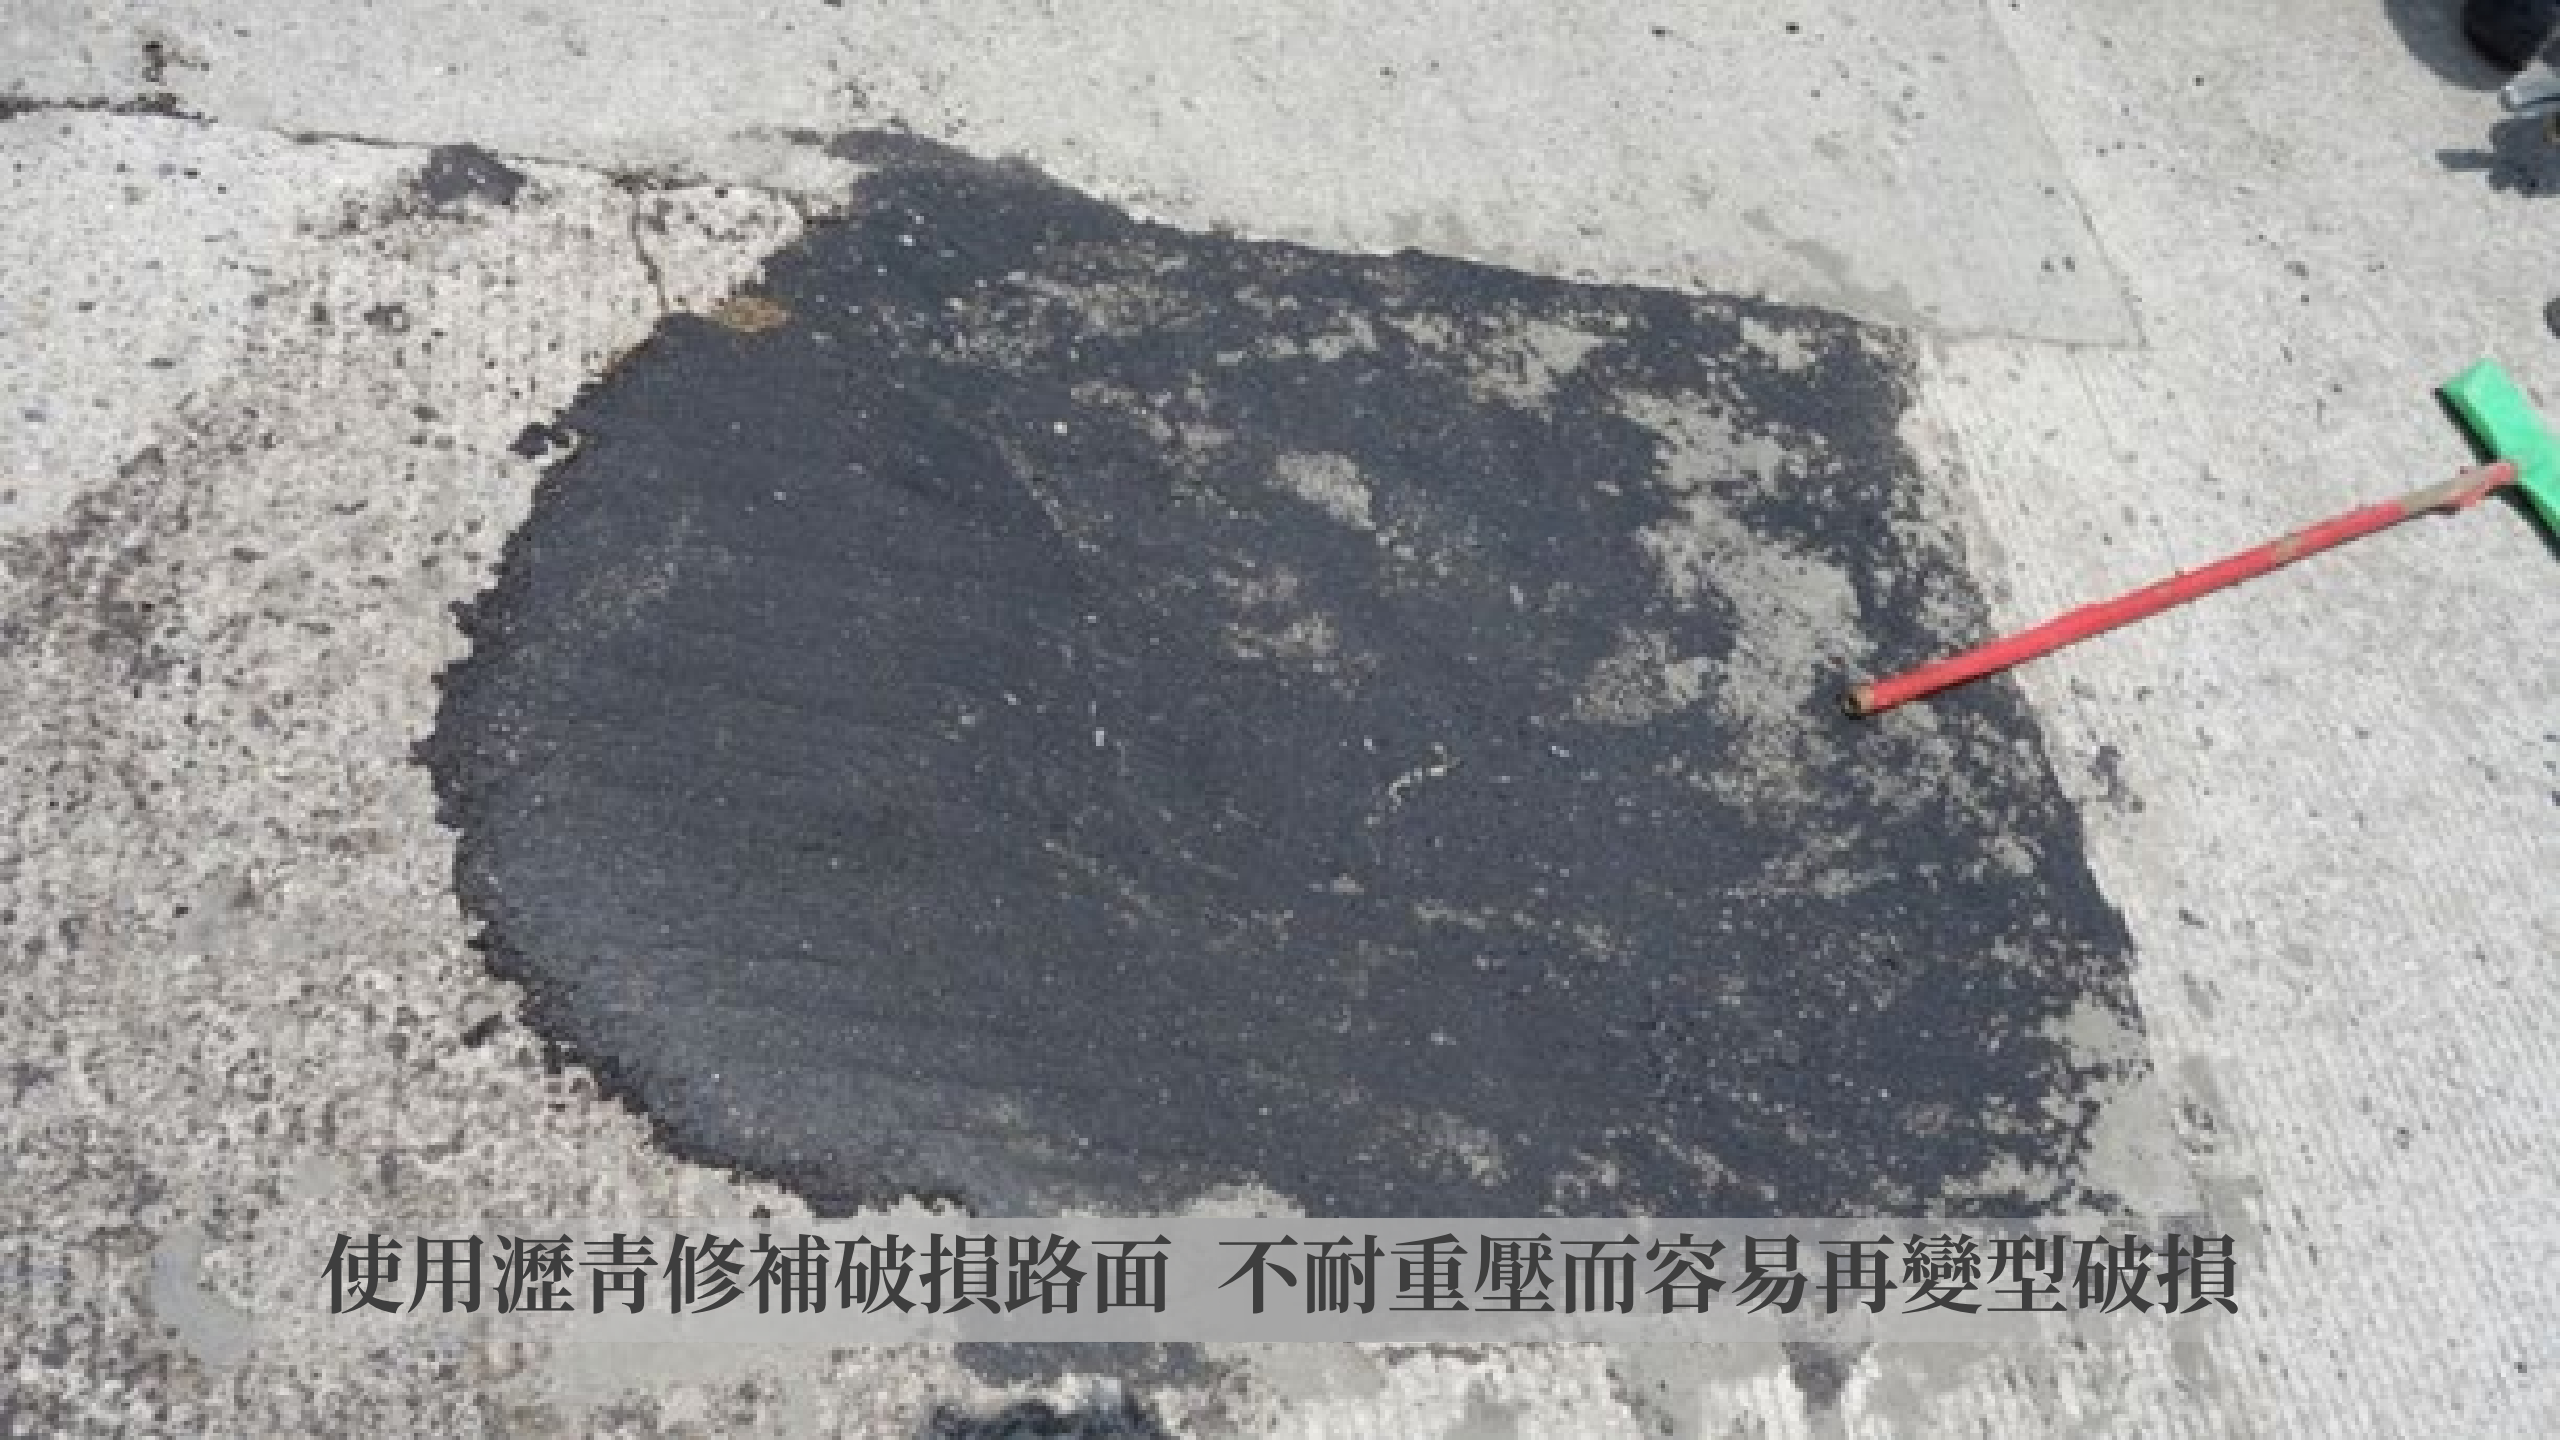
使用瀝青修補破損路面 不耐重壓而容易再變型破損

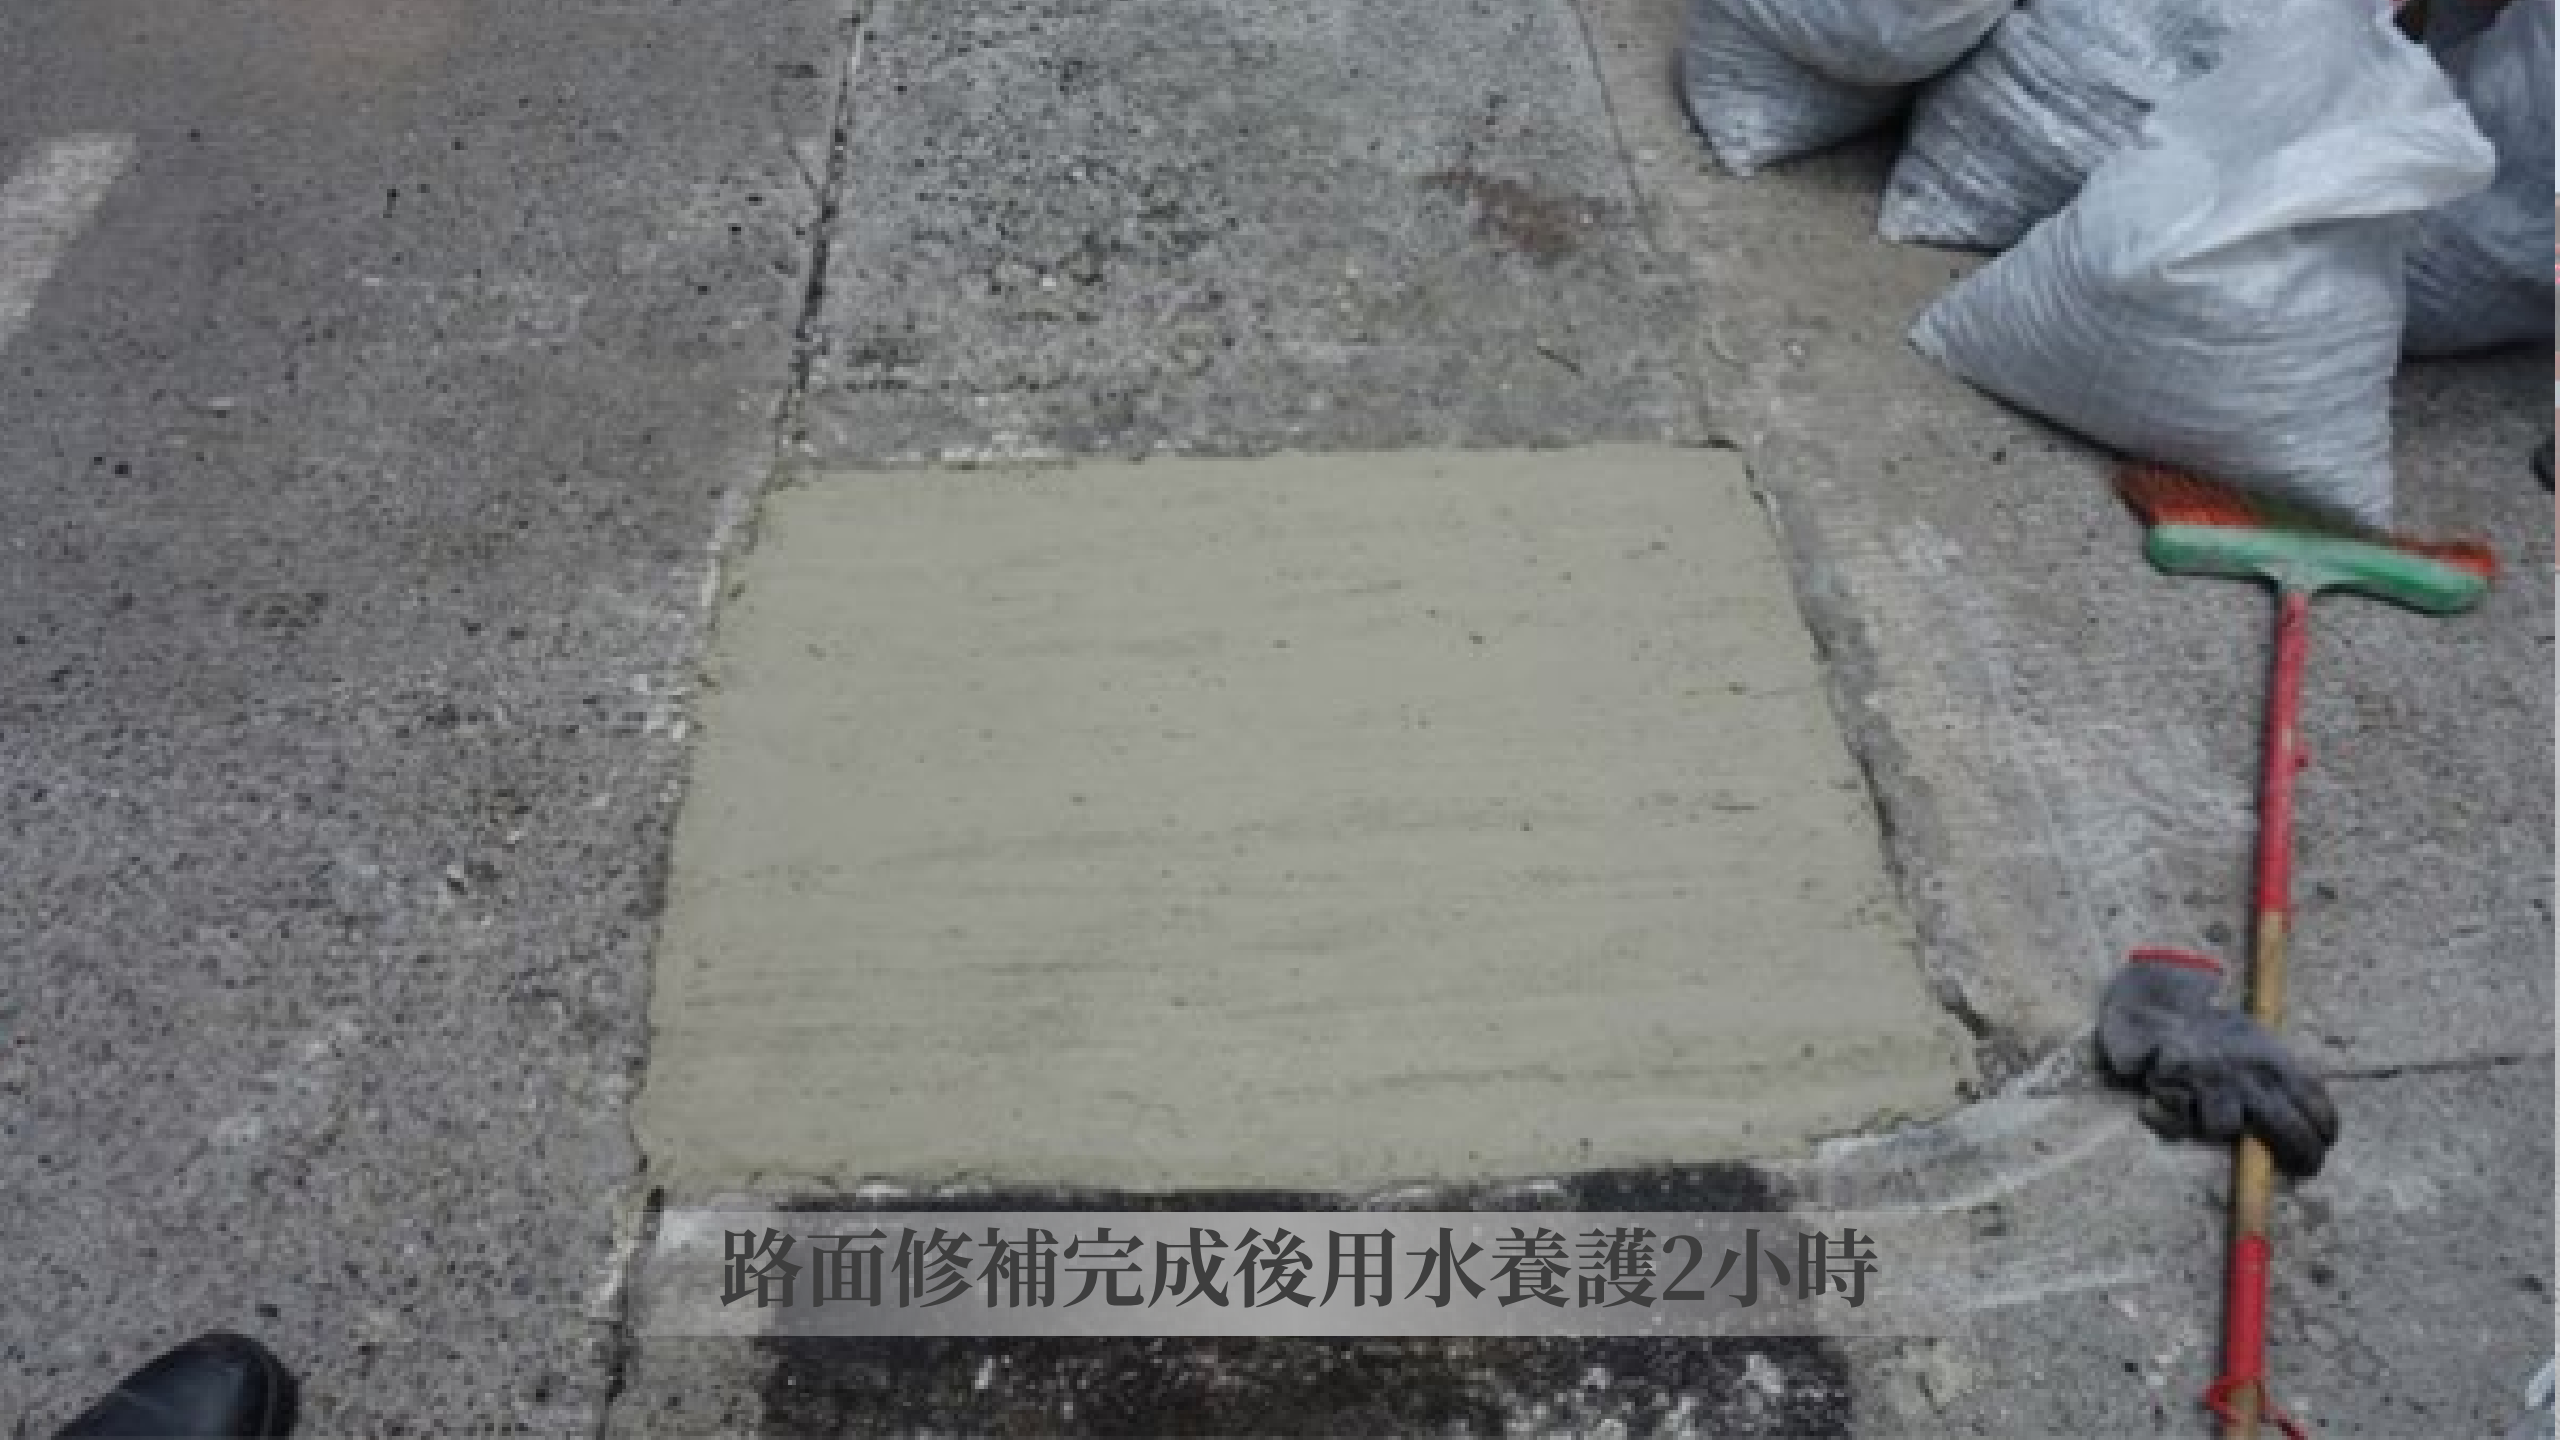
A rectangular patch of newly laid concrete is shown on a paved surface. The patch is a light tan color and has a smooth, slightly textured appearance. To the right of the patch, a broom with a green head and a red handle lies on the ground. A gloved hand is visible near the broom handle. In the background, several large white bags are stacked. The overall scene suggests a road repair or construction project.

路面修補完成後用水養護2小時
